# ARBORICULTURAL TREE SURVEY AND IMPACT ASSESSMENT

**SITE:** Land Adjacent Court  
Farmhouse, Matfield.  
**PREPARED FOR:** Clarendon  
Homes

PREPARED FOR: Clarendon Homes  
REF: FELLGROVE 1736  
Version: 02  
Dated: 27/08/2020

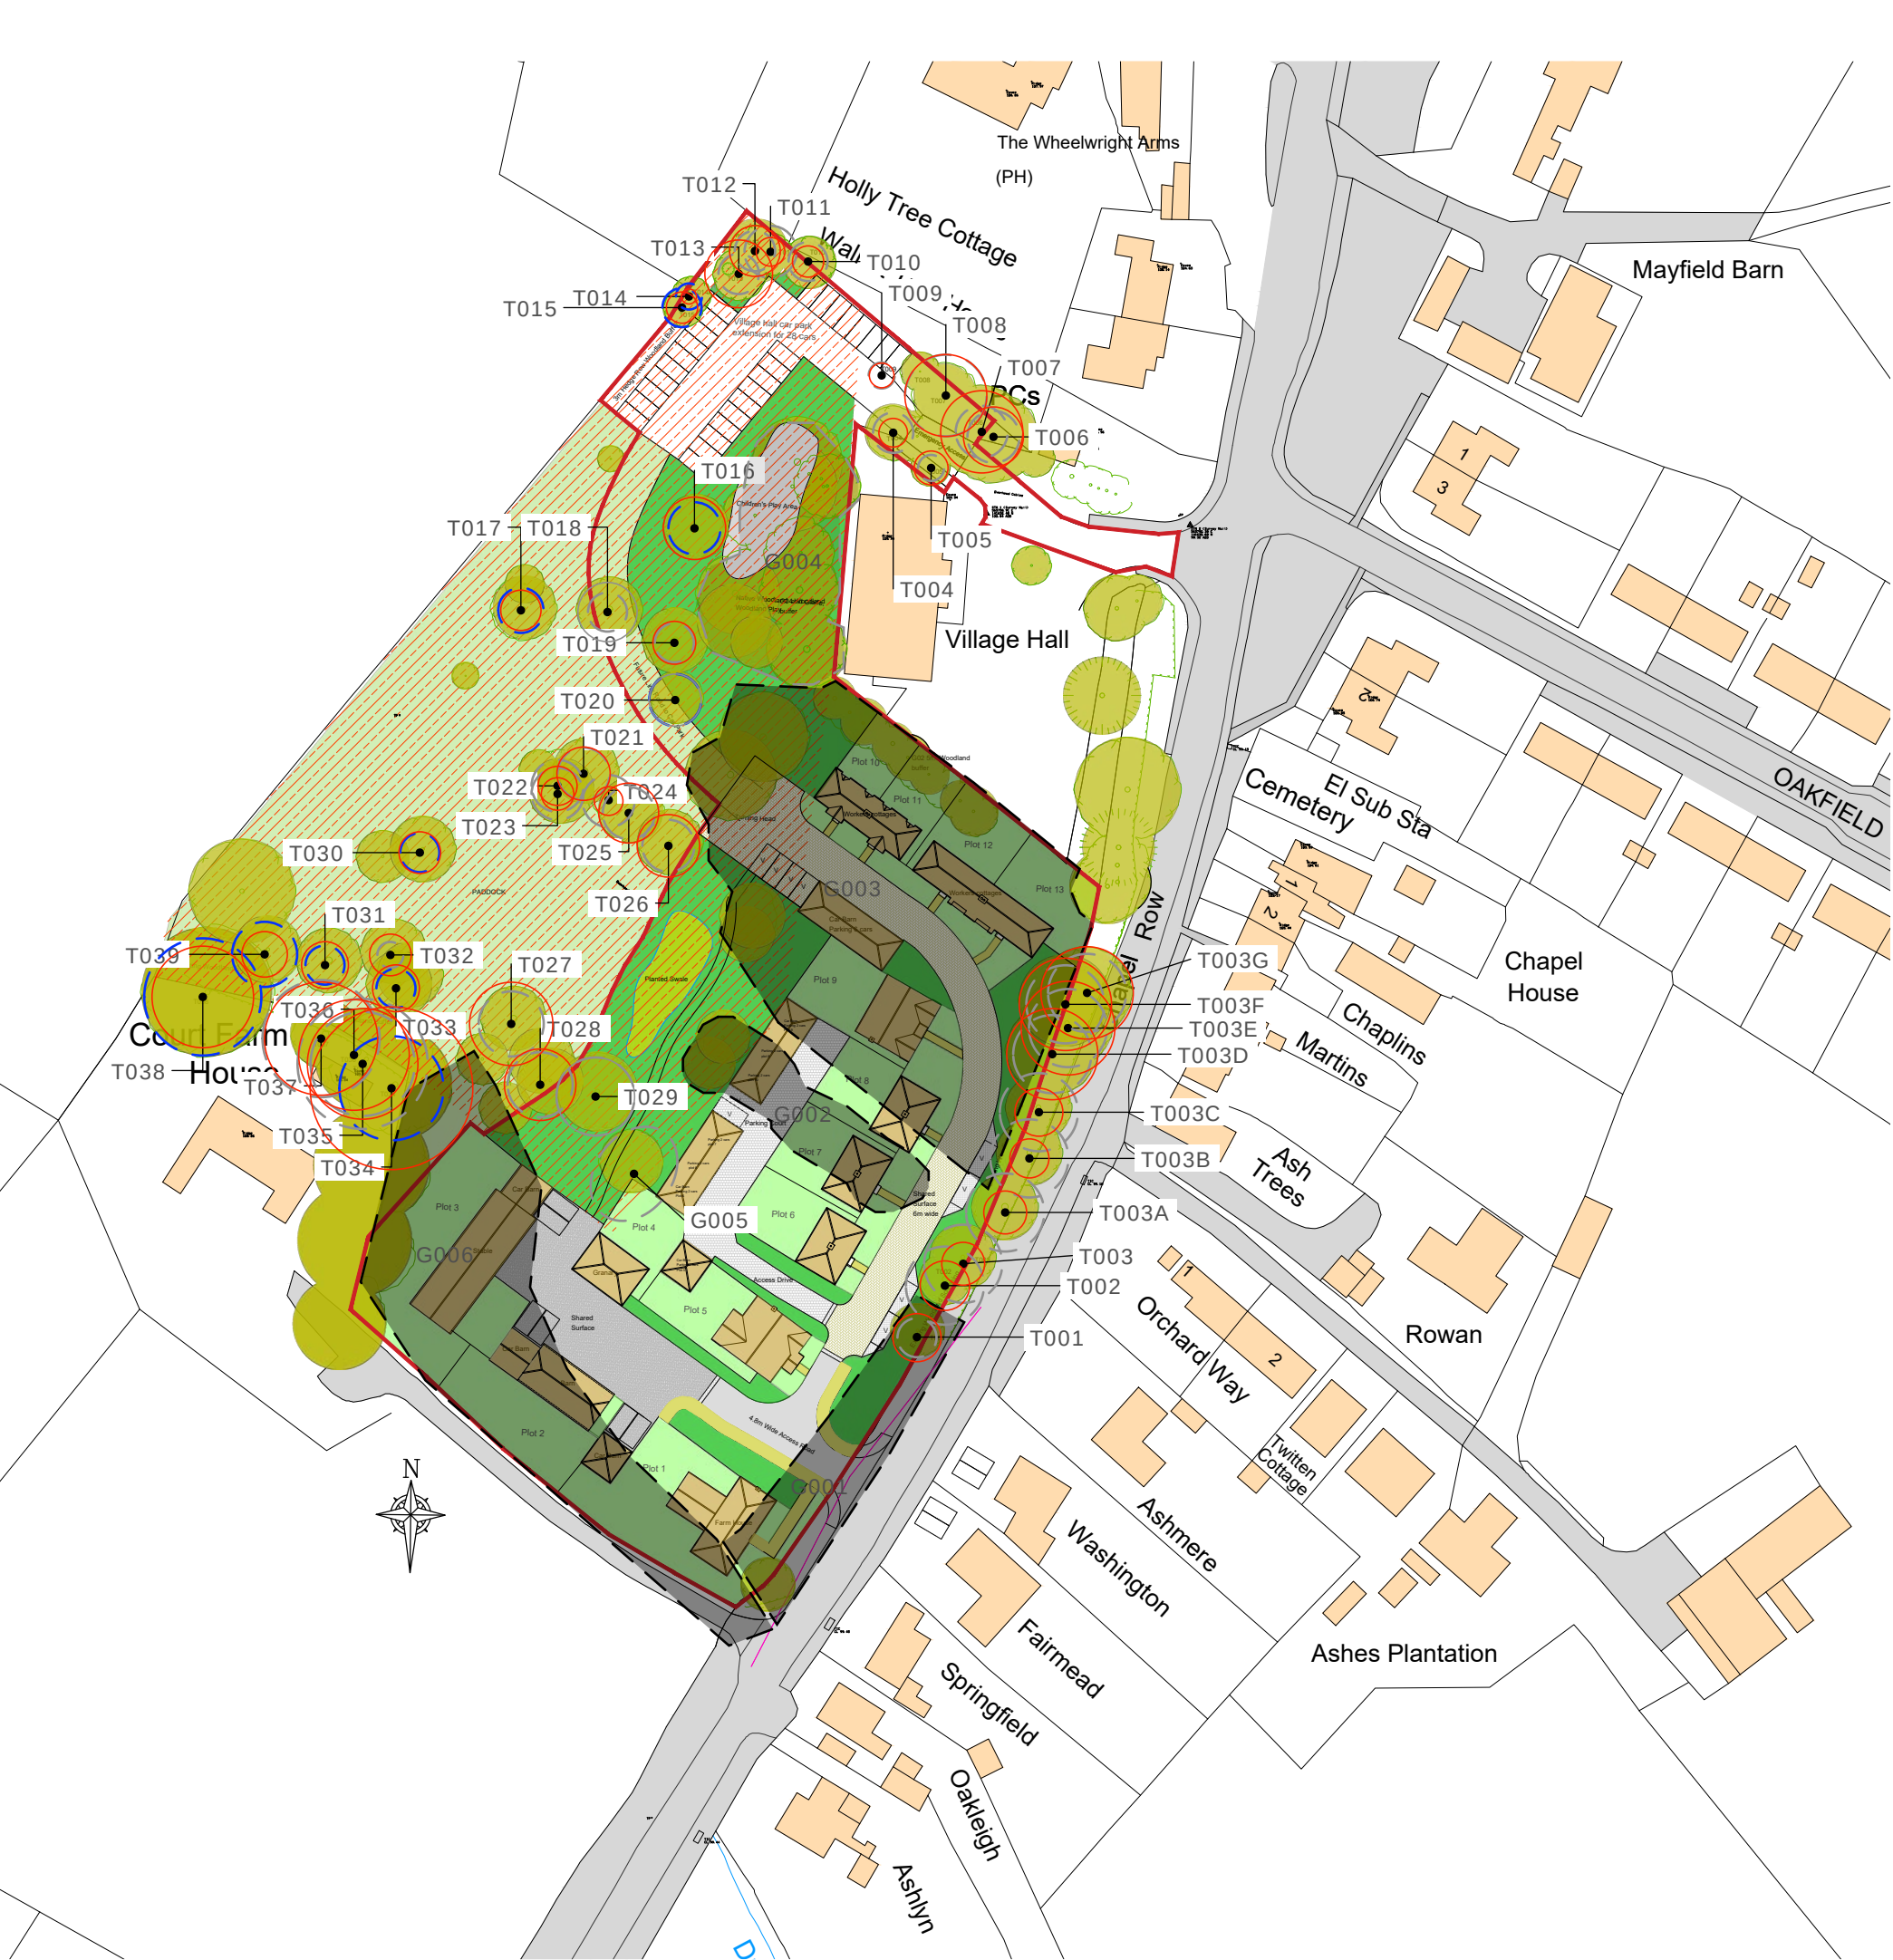
Trees recommended for retentions

Trees recommended for removal to facilitate the proposal.  
G001  
G002  
G003 - Recommend boundary trees retained if possible.  
G006

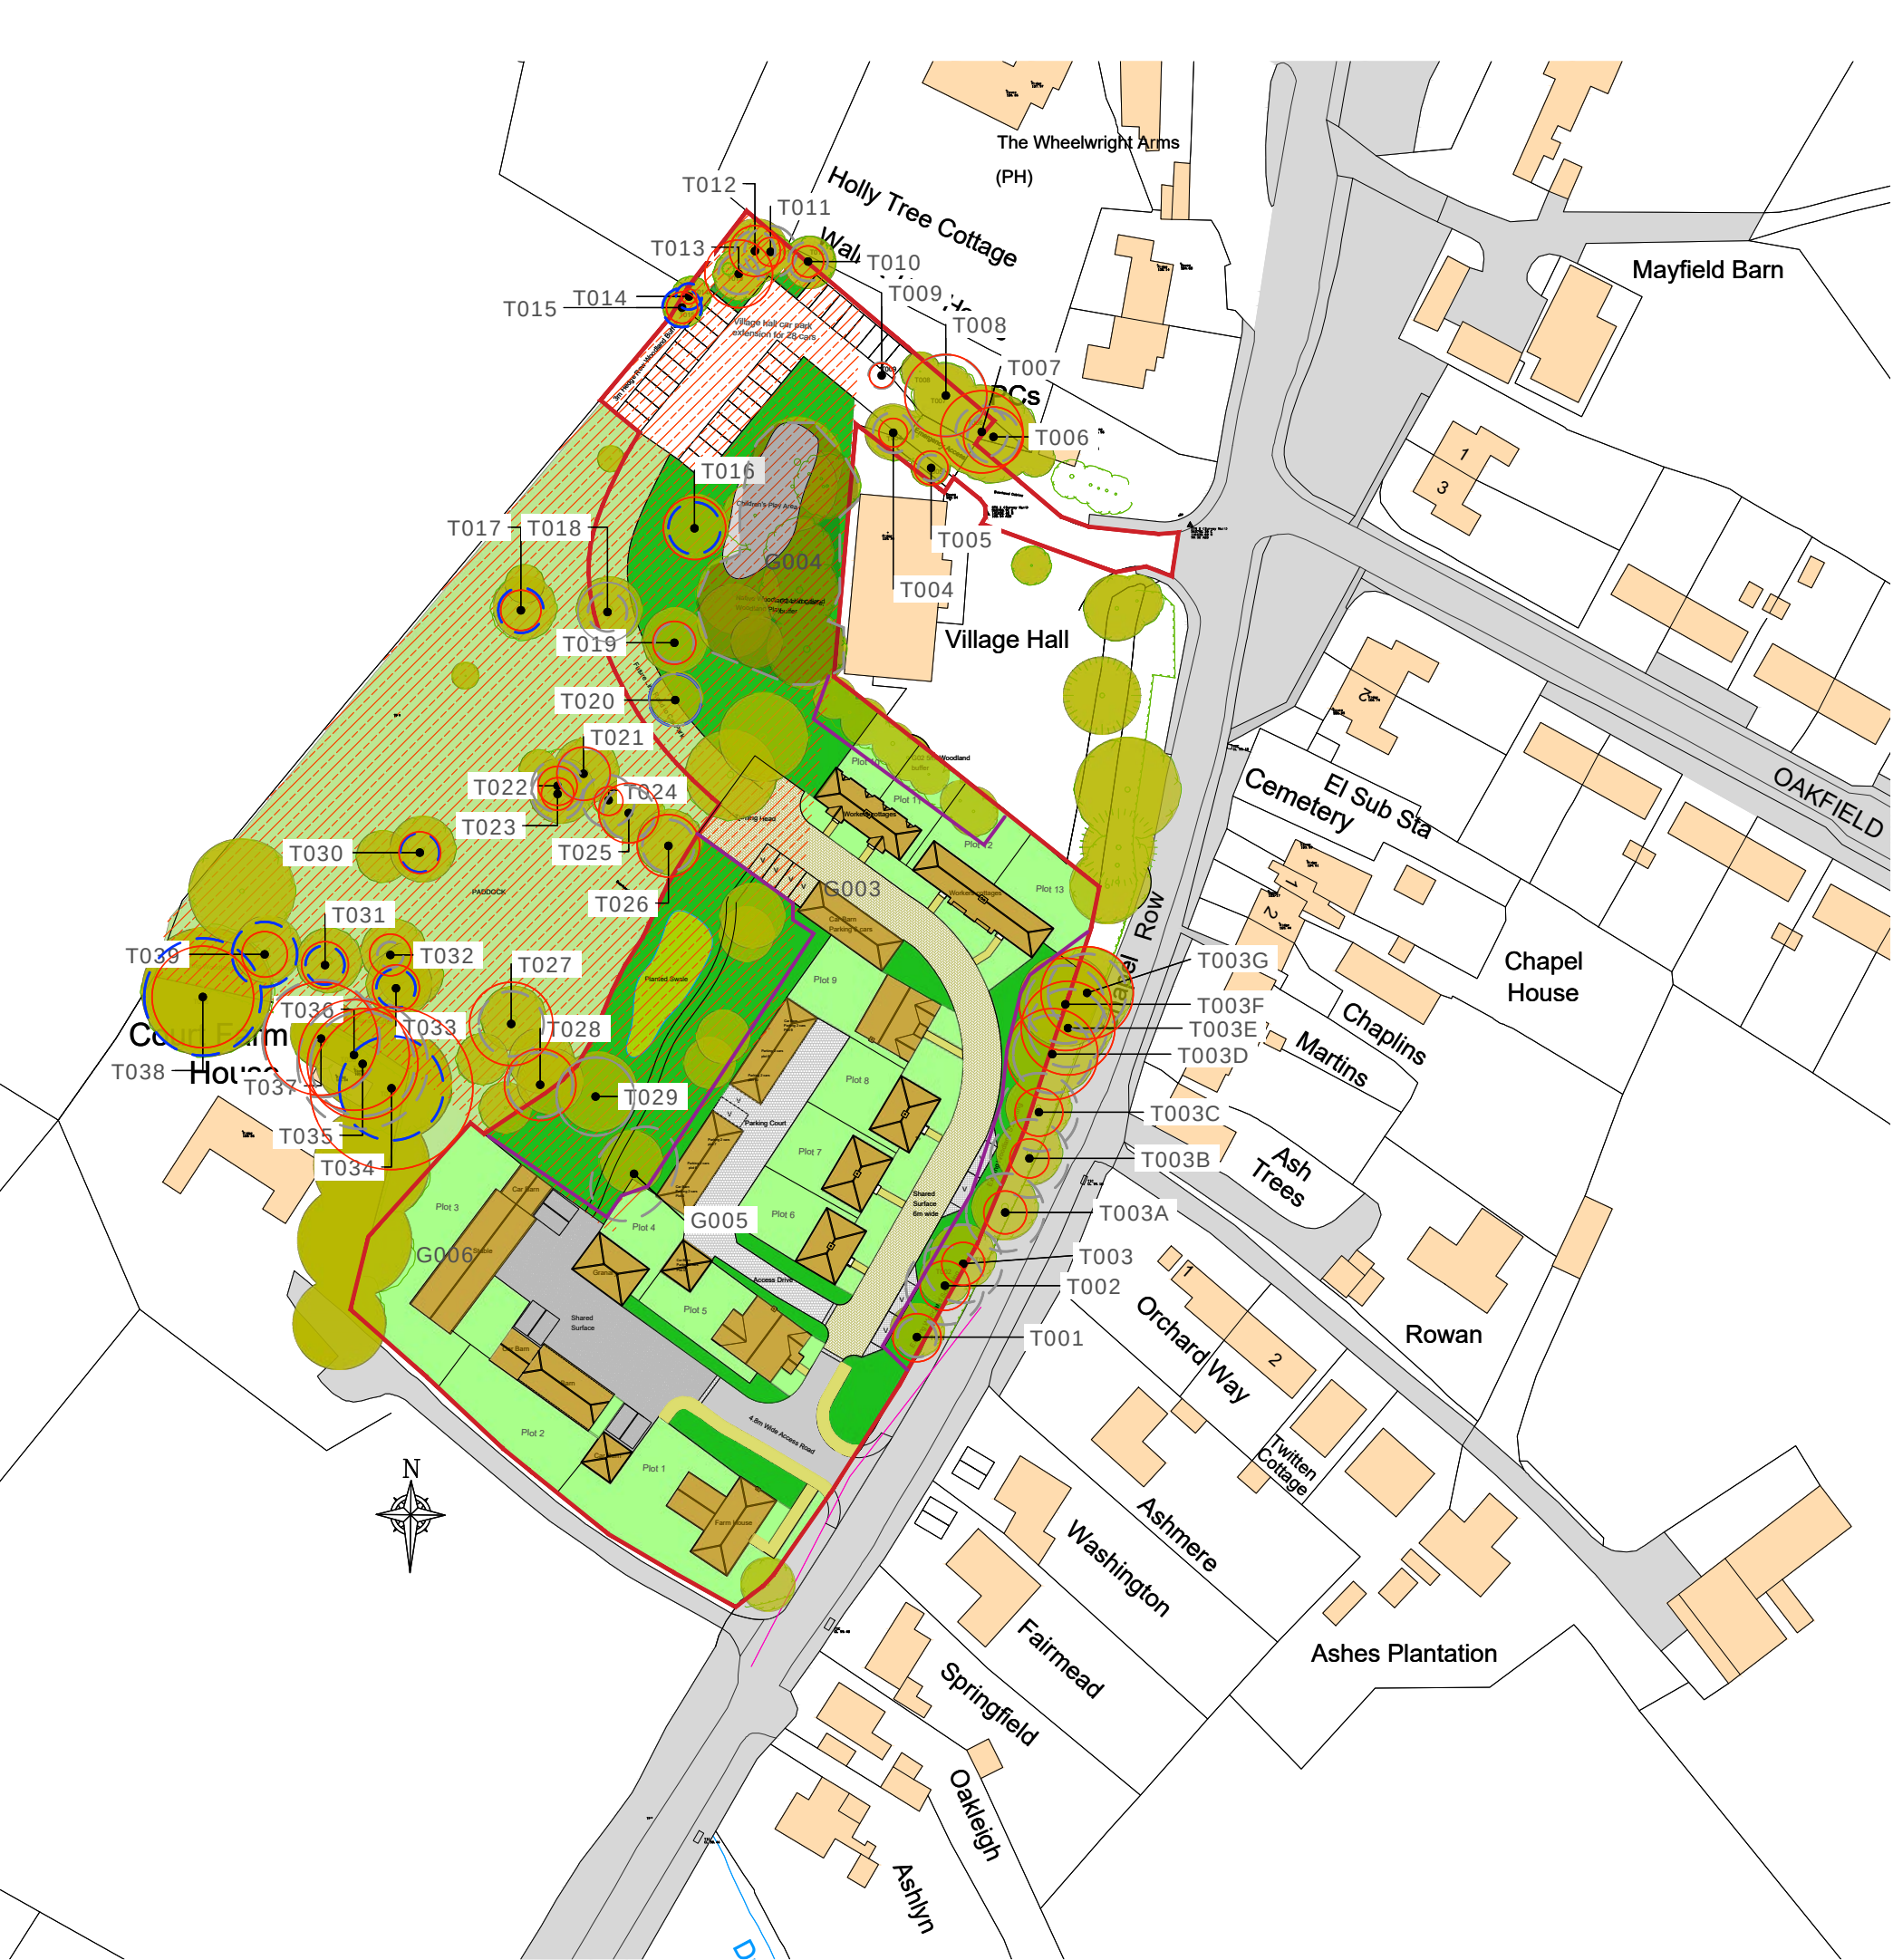
The proposal includes the installation of new lawns and fencing. Impacts can be found around T001 - T003G inclusive. To mitigate the impact only soft landscaping work are permitted within the soft landscaping area. Ground levels are not to be altered, only pedestrian machines to be used. No rotovators or excavators are to be used within this area.

The overall impact of the proposal on the localised tree population is moderate with the removal of G001, G002, G003 and G006 required to facilitate the proposal. To mitigate against the impact we are recommending where possible boundary trees within G003 remain to provide a screen. If the tree are found to be unsuitable for the position then replacement replanting is recommended.
